# Analysis of the Influence of Residential Electrical Installation Errors on Prepaid Kwh Meter Errors in the PT PLN (Persero) ULP Stabat Area

Harfan Diansyah<sup>1\*</sup>, Parlin Siagian<sup>2</sup>, Muhammad Erpandi Dalimunthe<sup>3</sup>

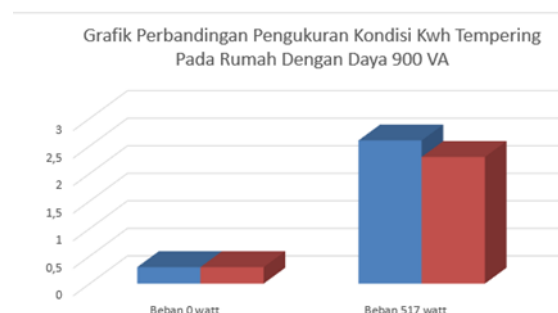
Judging from the measurement results, there is a current leakage that causes the load on the phase current to be lower than the load on the neutral current and when the load is 0 the measurement results should show the number 0, but the measurement results show the number 0.3 as shown in the table and graph above, This is what causes Kwh tempering. Because there is a difference in current of 0.3 A in the phase and neutral currents.

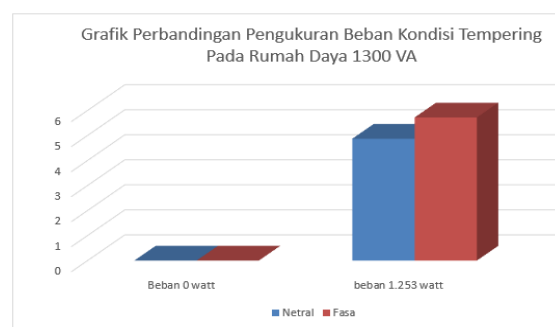
From the results of the check, there is a ground cable connected to the neutral cable of the installation. It can be seen from the measurement results that there is a difference in the phase and neutral current loads. When the load condition is active, the neutral current does not measure optimally because there is a ground cable connected to the neutral, causing a limping load on the neutral current. The current difference is 0.85 A.

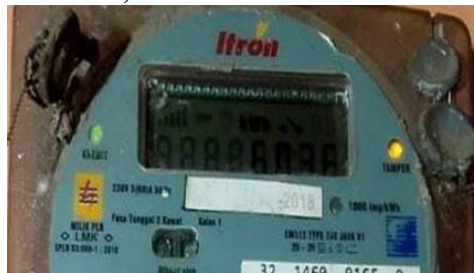
**Figure 5. Kwh Meter in Tempering Condition**

The image above shows the condition of the Kwh meter while still tempering. It can be seen that there is still a palm symbol and the yellow indicator light is on, which indicates that there is an installation disturbance. For this case, it is the grounding that is connected to the neutral of the installation, because it causes the kwh meter to appear as a palm.

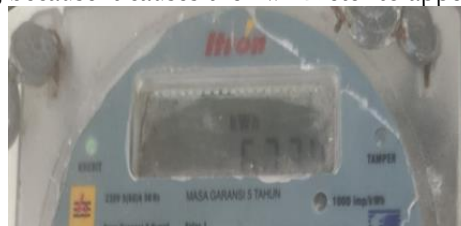
**Figure 5. Kwh meter in normal condition**

The image above shows that the Kwh meter is normal by removing the ground cable connected to the neutral cable. It can be seen that the palm symbol has disappeared and the indicator light has gone out.
