Moog Type Syringe Pump Repair Aitecs 2016 Advance d Sryinge Pump

Muhammad Athalla Akbar^{1*}, Imam Tri Harsoyo², Mohammad Rofi'i³

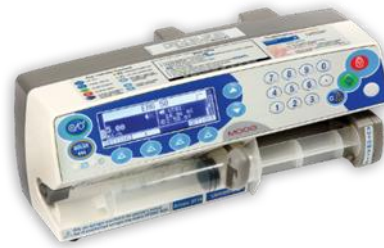
Figure 2 Moog brand Syringe Pump Tool

The image above is a Moog brand Syringe Pump type aitecs 2016 advanced Syringe Pump , before we make repairs it is a good idea to know the specifications of the tool, including:

Name	: Syringe Pump
Brand	: MOOG
Type/Model	: Aitecs 2016 advanced Syringe Pump
Power supply	: A 30W Output 12V, 2.5A
Battery	: Ni-MH (7.2V x 2.5Ah)
Display	: pixels 256 x 64 Illuminate
Made in	: Vilnius, Lithuania
Size	: 31 x 10 cm

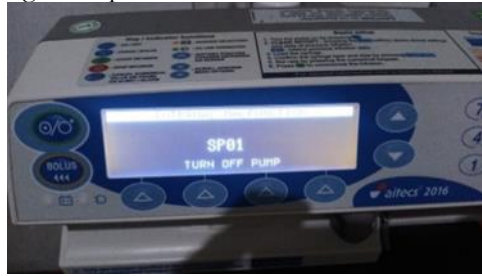
Figure 4 error codes on the Syringe Pump tool

Based on the report of the Syringe Pump tool experiencing damage, then conducted an observation of the cause of damage to the Syringe Pump. Then after that conducted an observation of the cause of damage to the Syringe Pump. After conducting an observation, it was found the cause of why the Moog Syringe Pump type Aitecs 2016 could not function properly. According to the user, the damage that occurred was that the tool could not detect the Syringe/injection and when the tool was turned on there was an SP01 code. Therefore, the medical equipment must be repaired so that it can be used and

function as it should. Therefore, a temporary analysis was carried out by measuring points on the Moog Syringe Pump type Aitecs 2016 advanced Syringe Pump tool . Checking the condition of the tool when analyzing damage to the tool, there was damage to the optocoupler sensor which is useful for reading the syringe and there is an SP01 code explained in the manual book, the damage is in the pusher sensor or what is called the optocoupler sensor to detect the movement of the syringe which experiences an error when analyzed the sensor is not properly installed on the board so that there is no voltage output from the sensor and the sensor cannot detect, and the syringe size sensor is broken because according to the user when using it is not good when installing the syringe too tightly so that it causes a break in the syringe size sensor. From the analyzed conditions, the repairs carried out were replacing the optocoupler sensor and gluing the syringe size sensor with adhesive glue. After repairs, do not forget to test the function of the tool as a sign whether the Syringe Pump tool is suitable for use or not.

The image above shows damage to the Moog Type Aitecs 2016 Syringe Pump tool which has the code SP01 which when shown in the manual book is damage to the pusher sensor or optocoupler sensor to detect the movement of the syringe which experiences an error so that the syringe cannot be pushed and move as it should.

And there is a broken syringe size sensor section due to poor user usage, the syringe is installed too tightly which causes the syringe size sensor section to break and cannot detect the syringe size.

The following are the results of the analysis and repair of the Moog brand Syringe Pump type Aitecs 2016 which was carried out based on the manual book which recommends checking the pusher sensor when the SP01 code appears on the tool .

The process of replacing the optocoupler sensor component and the Syringe size sensor is done by disassembling the Syringe Pump tool first. Then remove the two sensor components in the mainboard circuit carefully so as not to damage other components. After being removed, then repair the error Optocoupler sensor component replaced with a new and normal component. And repair the syringe size sensor by re-gluing the broken part with glue on the broken syringe size sensor part after all is replaced and repaired, reinstall the Syringe Pump as before.

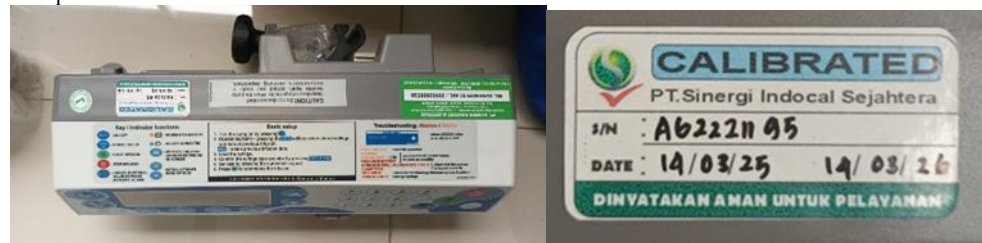
Figure 7 Image of calibration stamp

Below is a stamp that shows whether the MOOG brand Syringe Pump type Aitecs 2016 has passed the functional test or not.
