## Analysis of The Existing Condition of Cibangreng Lake Lebak Regency

**Abstract:** Lakes have strategic potential and benefits that are beneficial both ecologically and economically, including as part of a region's water management system, reservoirs, water catchment areas, inland fisheries cultivation locations, part of irrigation systems, and potential as tourist attractions. Most research on lakes in Indonesia is conducted by analyzing water quality and tourism conditions in the lake. Meanwhile, this study will discuss the analysis of existing conditions by considering the type of land use in the Situ Cibangreng area, Lebak Regency, and the analysis of indications of the Situ Cibangreng area in Lebak Regency, Banten Province, West Java. The method used in this study is qualitative analysis. During the data collection stage, the research team will explore the study area through field observations to obtain a general picture of conditions within the Situ area. The survey method is carried out using Topographic Measurement Methods, Geographic Information Systems (GIS), 3.2.2 Aerial Photography with Drones/UAVs and using Spatial Data Analysis. Based on field observations, Situ Ci

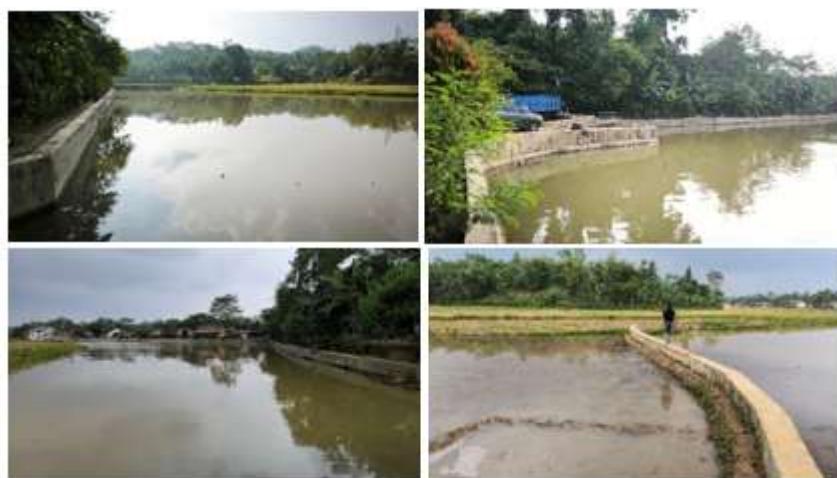
**Figure 2.** Existing Condition of Situ Cibangreng.

Surveys show that during the rainy season, the Cibangreng Lake reaches its highest water level of 2 meters and has two inlets and two outlets. For more details, see the following image.

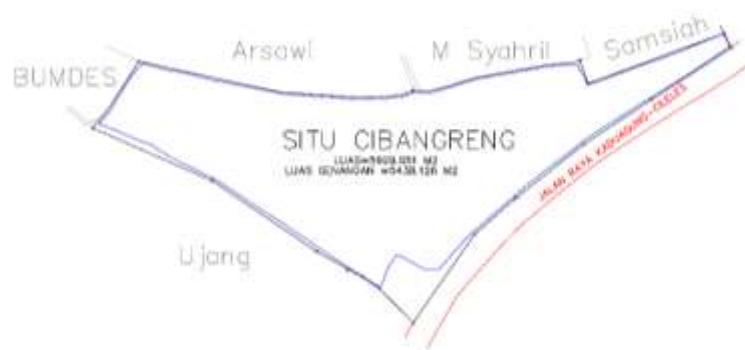
**Figure 3.** Situation Map of Cibangreng Situ.

The GPS RTK measurements revealed an area of Situ Cibangreng of 5,929.951 m<sup>2</sup>. There is a gap between the measured area and the data on the Goods Inventory Card (KIB). Further details can be found in the following table.

The difference in the area of the lake from the measurements and the KIB data at Situ Cibangreng is 929,951 m<sup>2</sup>. Meanwhile, the results of the area depiction can be seen in Figure 3 as follows

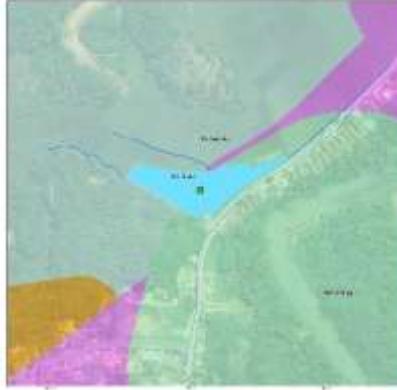
No	Spatial Planning	Cut on the Map	Area Function
1	Lebak Regency Regional Regulation Number 7 of 2023

Flood Control and Water Resources
2	Banten Provincial Regulation No. 1 of 2023

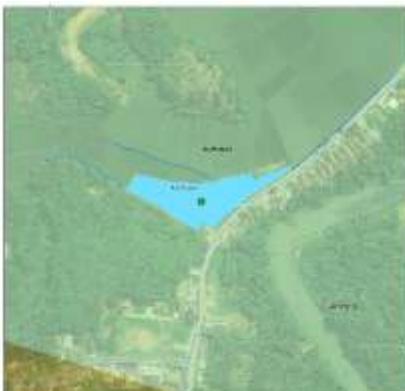
Flood Control
